## **O3.3b STUDY VISITS**

**THEMATIC AREA 2: PROVISIONS FOR VULNERABLE ROAD  
USERS**

**RADAR – Risk Assessment on Danube Area Roads**

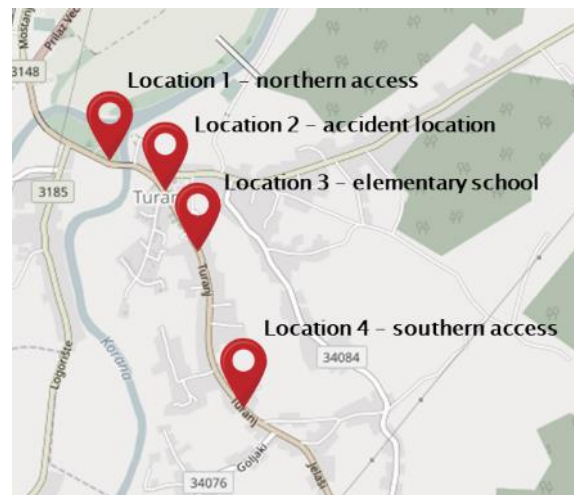
Day of the week	Location	Number of vehicles	Number of vehicles in peak hour (3 p.m. – 4 p.m.)
Friday (peak day)	L1	16.904	1.272
	L2	15.946	1.272
	L3 (school zone)	15.024	1.174
	L4	14.169	1.117
Wednesday (characteristic day of the week)	L1	14.115	1.048
	L2	12.372	956
	L3 (school zone)	11.536	891
	L4	10.685	843

Both historic and observed traffic volume data clearly show that Turanj is a very busy location. DC1 road represents the shortest connection of Slovenia with Bosnia and Herzegovina and is frequently used by trucks trying to avoid the tolled motorway network. Official automatic traffic counts show around 10% share of heavy vehicles in traffic flow. Below is the sample of the counting carried out manually at the specified locations during the assignment.

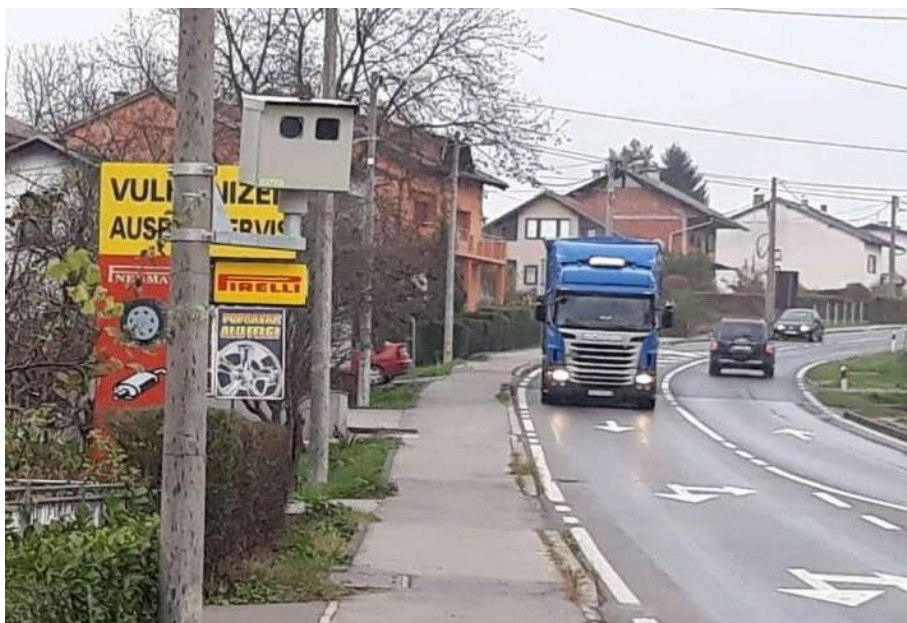
- **Speed enforcement cameras in the school zone**

To strengthen the surveillance and identification of vehicles over-speeding the limit of 50 km/h (option of lower speed were not found relevant due to the traffic volumes).

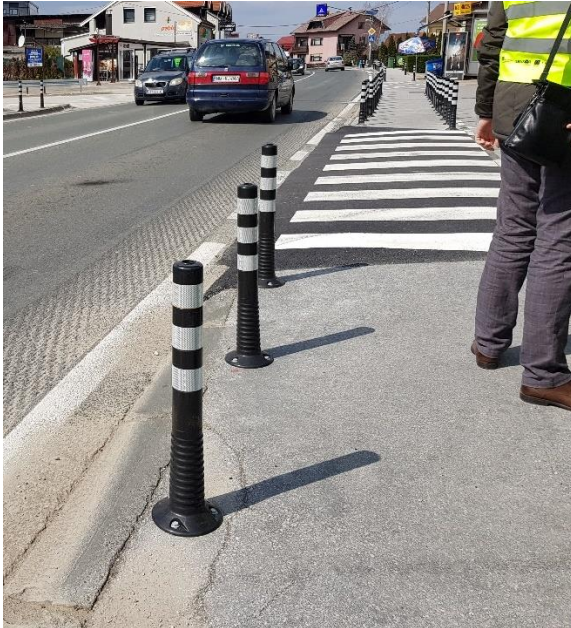
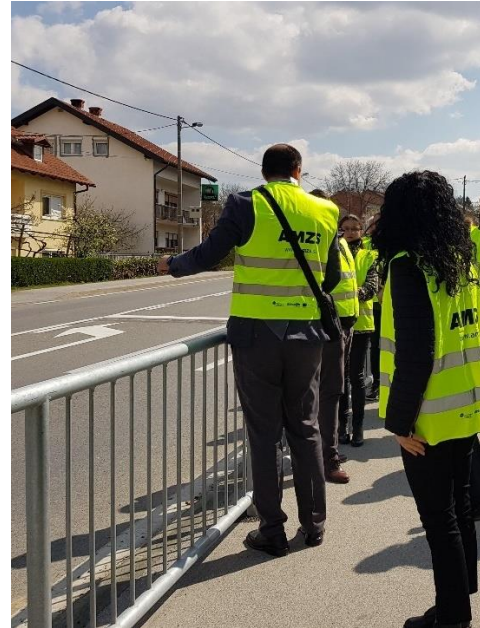
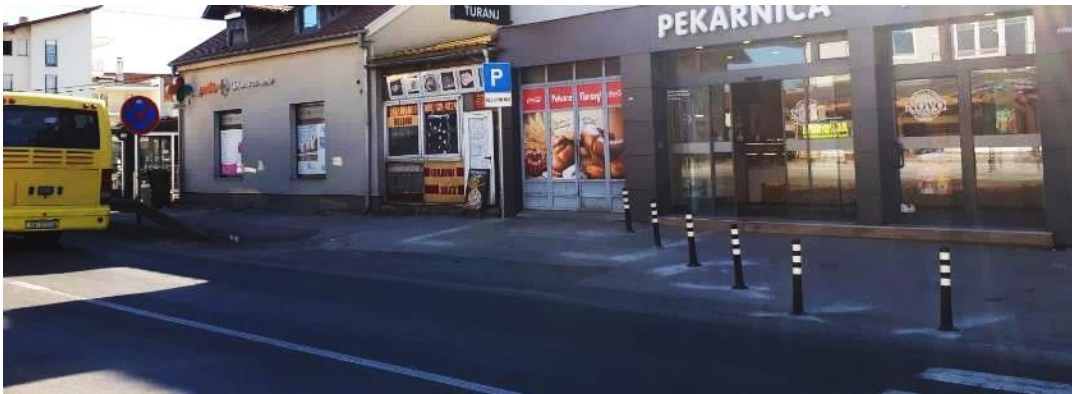
- **Measures to eliminate on-street and on-sidewalk parking: bollards, sidewalk parking tickets**

In order to prevent drivers from frequent stopping at pedestrian facilities, blocking accesses and safe passage, while increasing risk of collision at numerous spots along the through road (close to school, shops and services), bollards and pedestrian fencing was used to separate pedestrian flows from other traffic and disable fraudulent parking. With these, enforcement through penalty tickets was introduced.

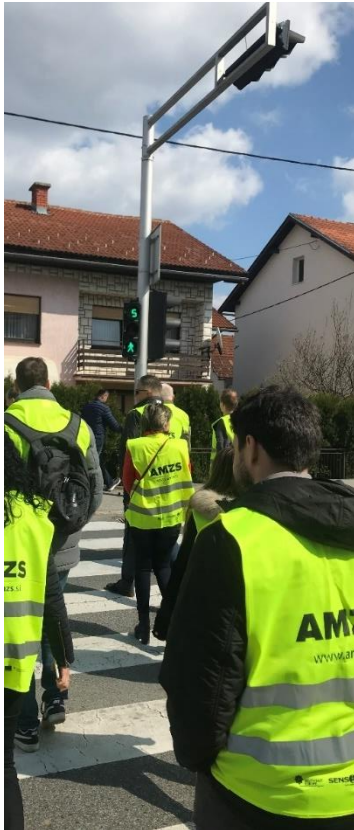
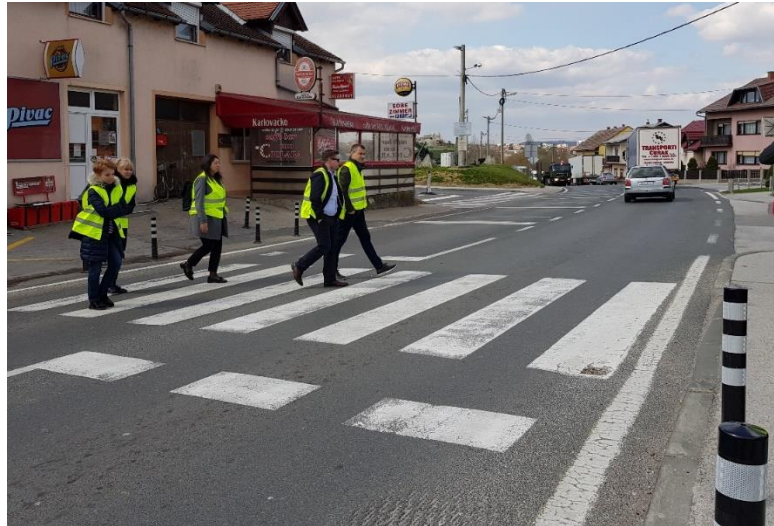
- **Increased visibility and quality of crossing facilities**

Junctions and pedestrian crossings were equipped with improved signalization, measures also included improvements of visibility (new road markings and signing, lighting upgrades).

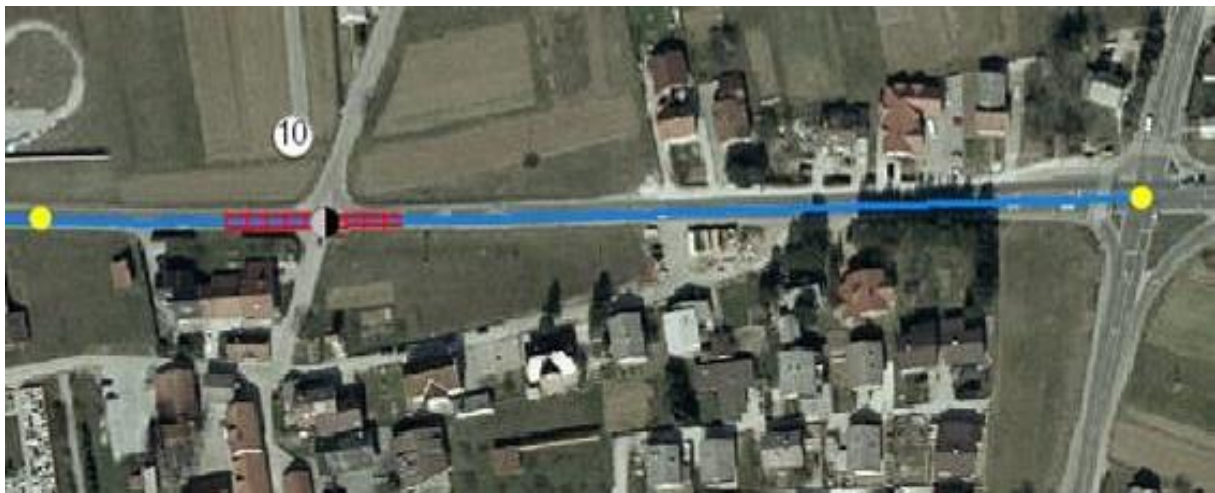
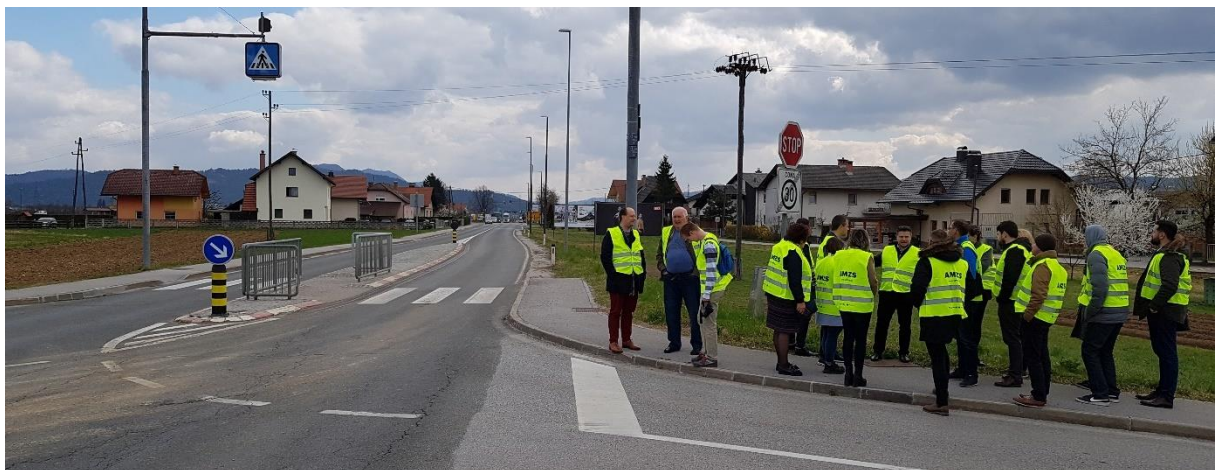
After the city centre tour the participants were taken to the outskirts of Ljubljana, municipality of Šentjakob pri Ljubljani, where representatives of AMZS presented a recently completed project of upgrading pedestrian crossing, which helped to make a regular school route across a busy state road much safer.

In terms of the project of Šentjakob, the objective of the crossing upgrade was to provide safer conditions for crossing a busy state road. The spot is frequently used by local communities and is also part of the regular route to school for many children.

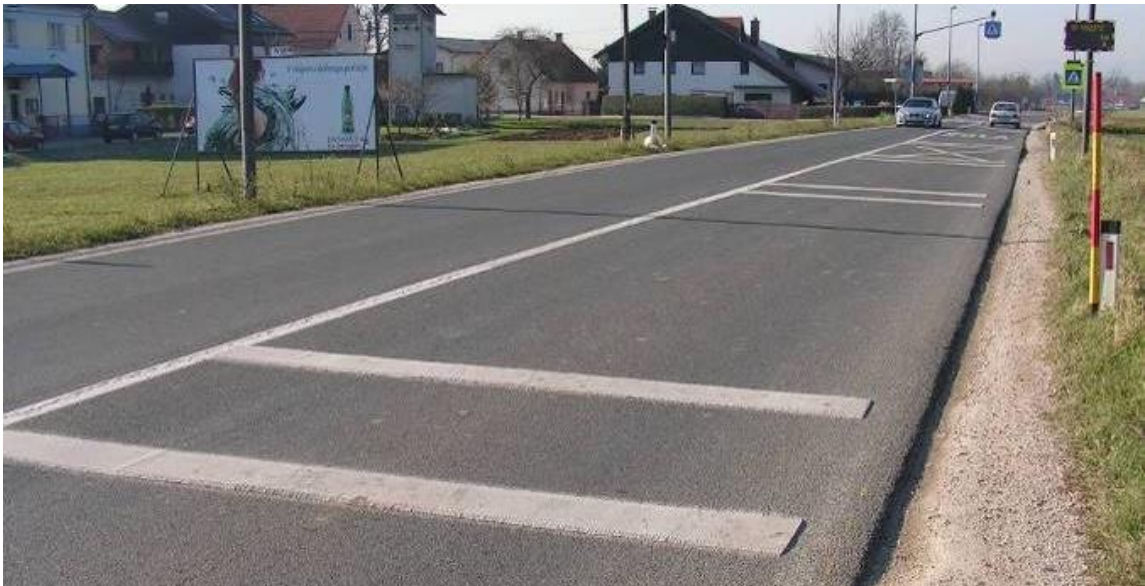
**2) Installation of rumble (deceleration) strips**

First stage of the upgrade introduced rumble strips to enforce deceleration of vehicles in front of the crossing, together with improved road marking and signing.

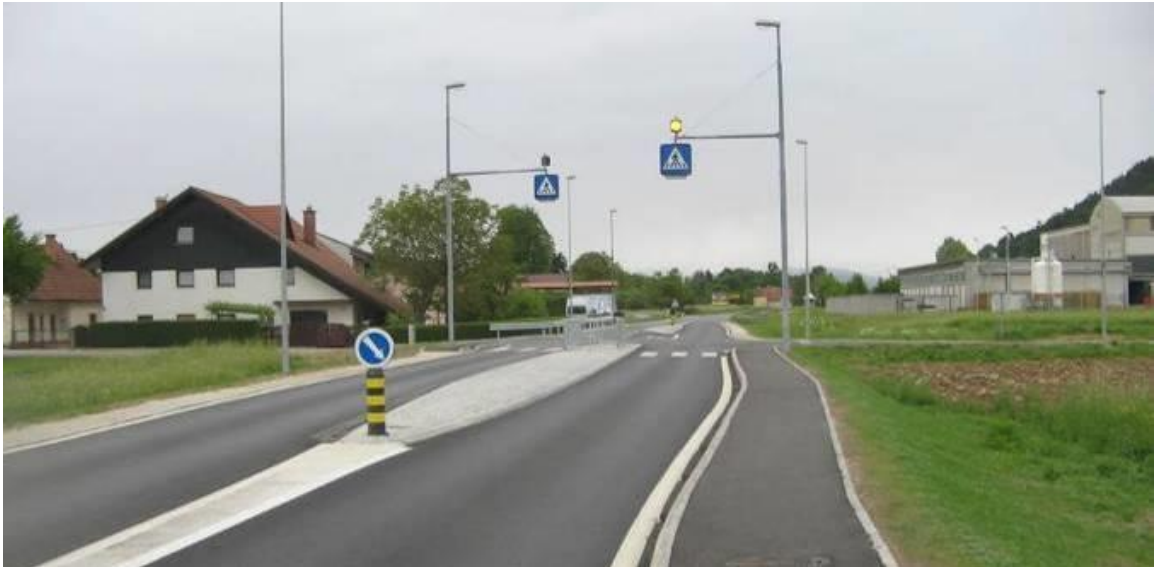
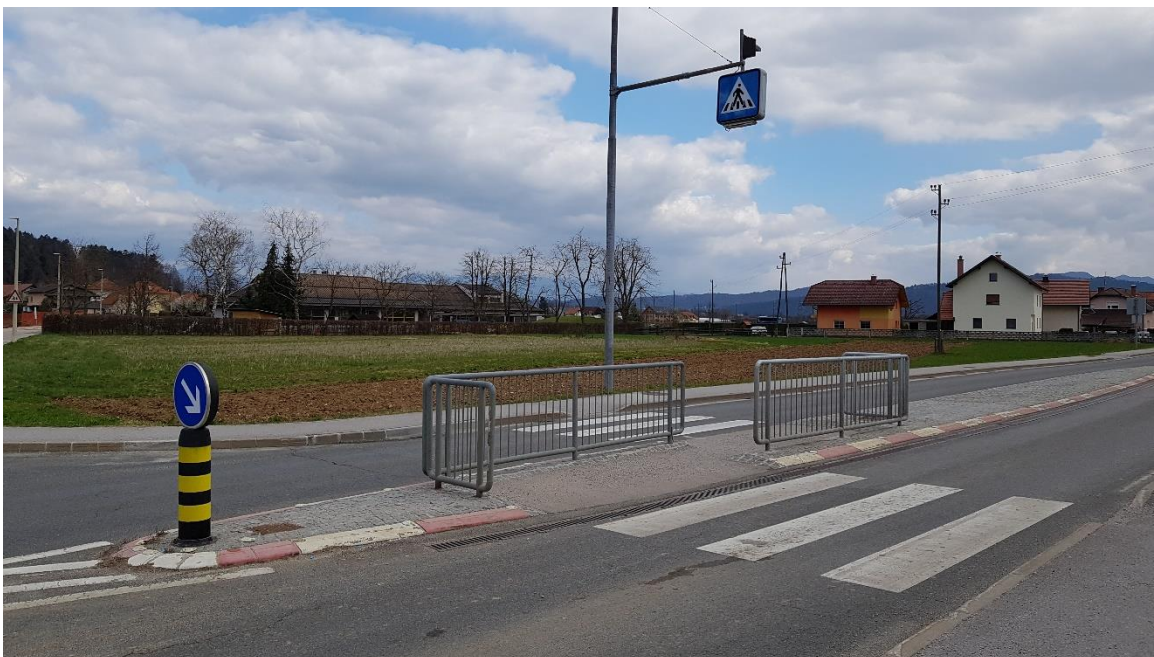
### 3) Full implementation – new layout with central refuge island

Second stage finalized the layout with a brand-new refuge island complemented with guard rail, which effectively eliminate potential collision points between pedestrians and traffic.

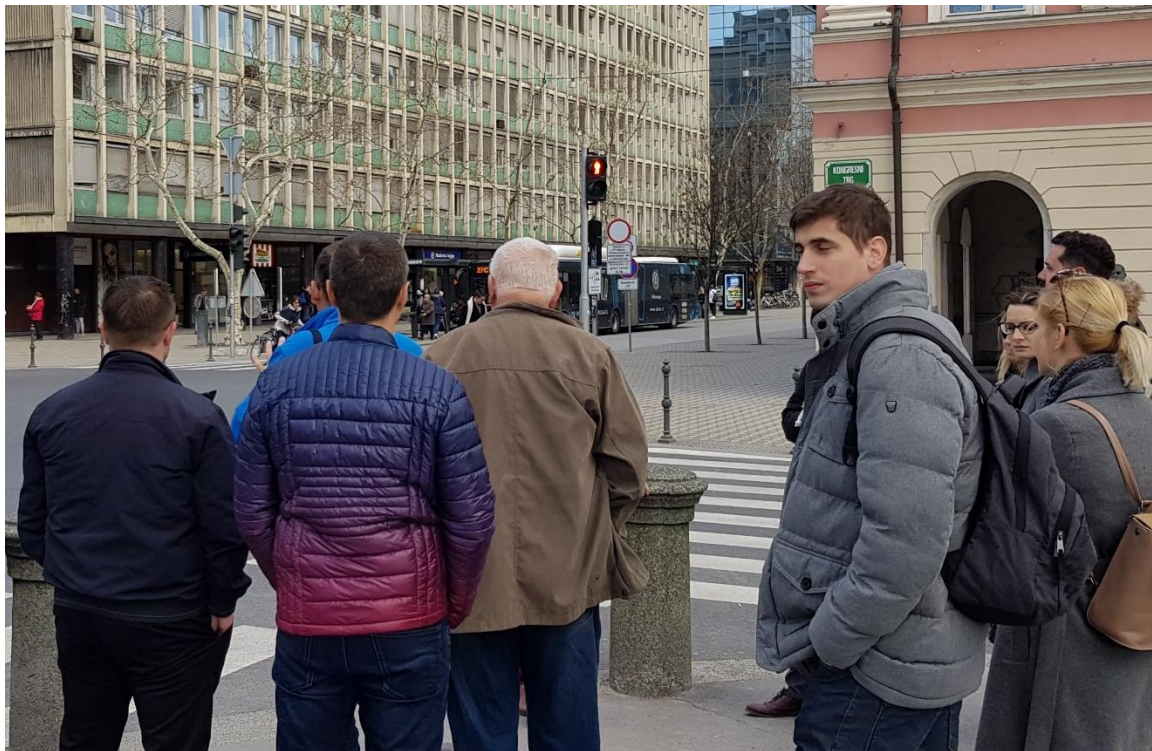
Participants also visited Slovenska cesta, one of the major city trunk roads, that has been transformed from a busy 4-lane urban road (with dedicated public transport lanes) into a “shared use space”. Two lanes reserved for public transport remained, however, the rest has been transformed into wide pedestrian area. Bicyclists can ride in the bus lanes (where speed is limited to 30 km/h), as well as on pedestrian parts (where they have to respect the speed of pedestrian flows). Pedestrians can cross the road anywhere they want.

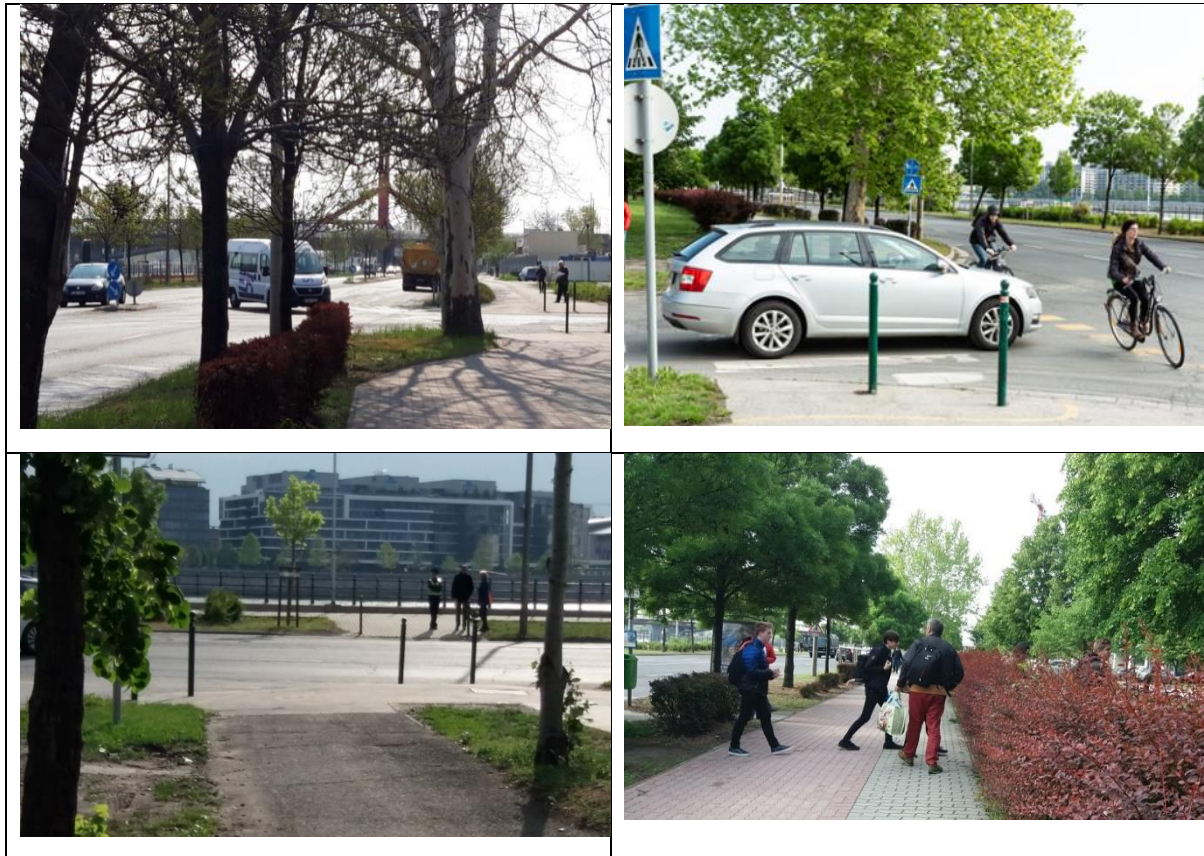
**Figure 1:** Photos of location, presenting some of the problems affecting vulnerable road users

This junction is an accident cluster which has been recently revised from road safety point of view (revision was led by the Road Safety Research Centre of KTI Non-profit Ltd.). The revision has been made as a teamwork, the problems and risks were examined from the perspective of the different road user groups (motor vehicle drivers, cyclists, users of public transport, pedestrians).

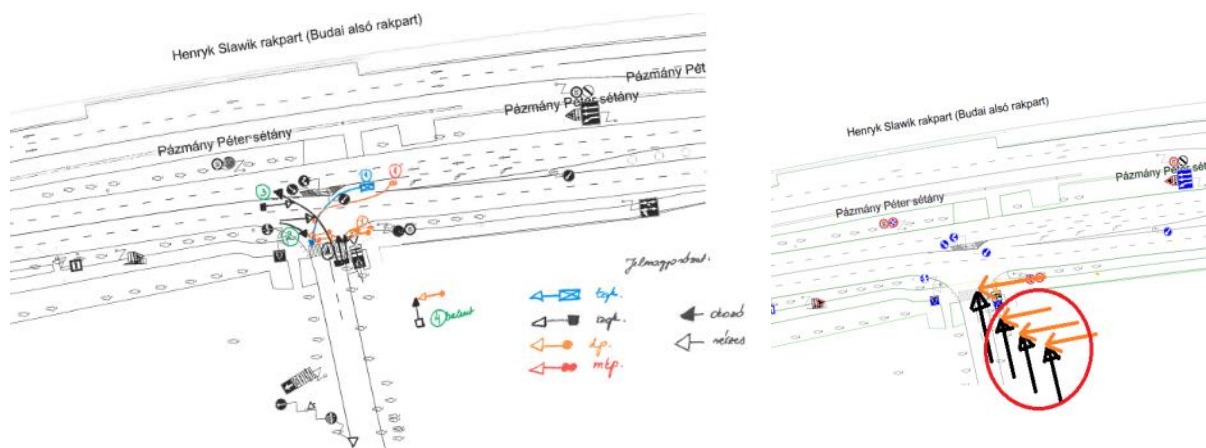
**Figure 2:** Location and type of accidents at the site (2017-2019)

Figure 2 illustrates the site plan of the accident cluster and accident data from the last 3 years (2017-2019). Out of the 4 accidents from the subordinate direction, 3 accidents (crossing collisions between cars and cyclists arriving from the right on the bicycle path) occurred during a construction, when the bicycle path was covered by a 2-meter-high wall, which negatively affected the visibility of the cyclists (these 3 accidents are special cases, they were the consequence of a temporary problem).

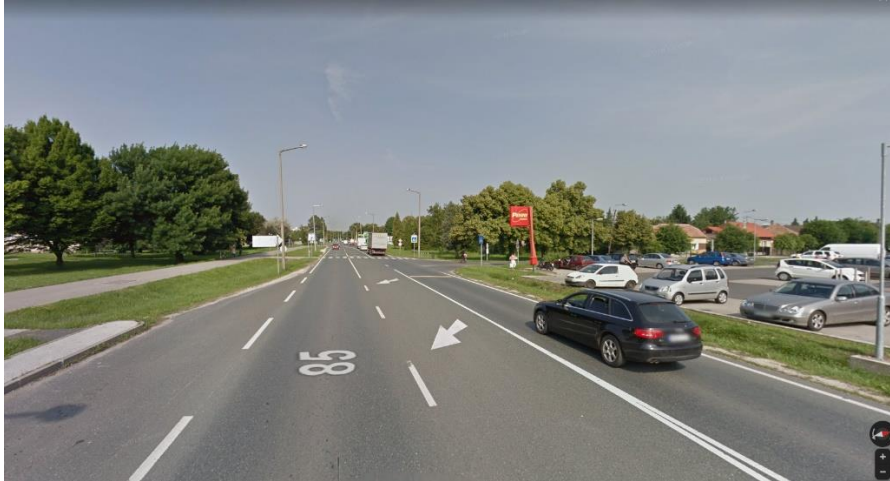
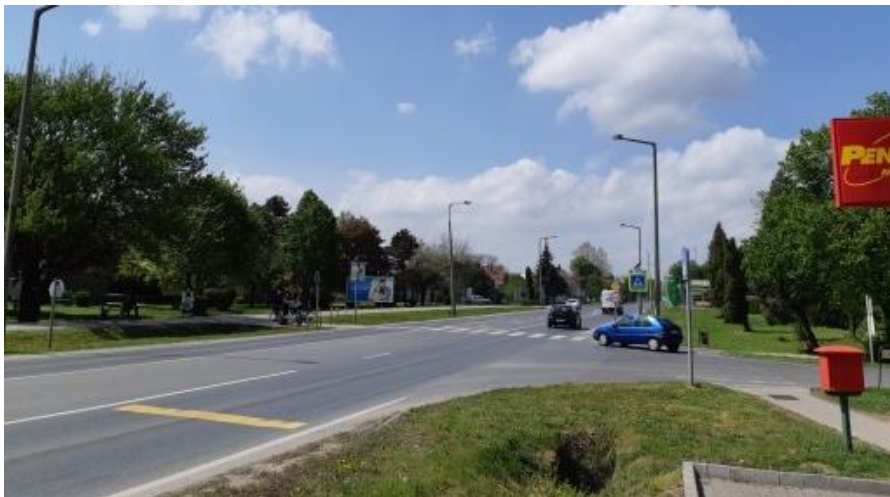
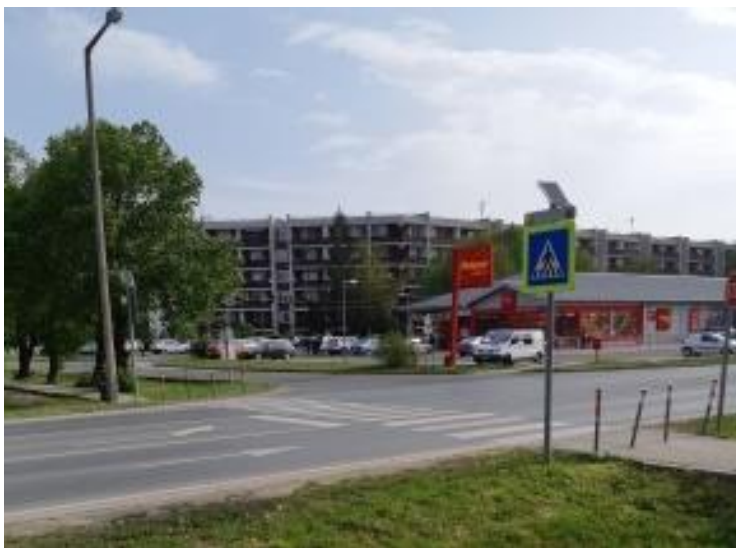
**Figure 4:** Photos of location

The pedestrian crossing in question can be found in the western part of the country in the city of Kapuvár. The crossing and its close environment is dangerous, 2 fatal accidents (pedestrian hits), and several accidents with serious and slight injuries occurred in the last 3 years (see Table 1).

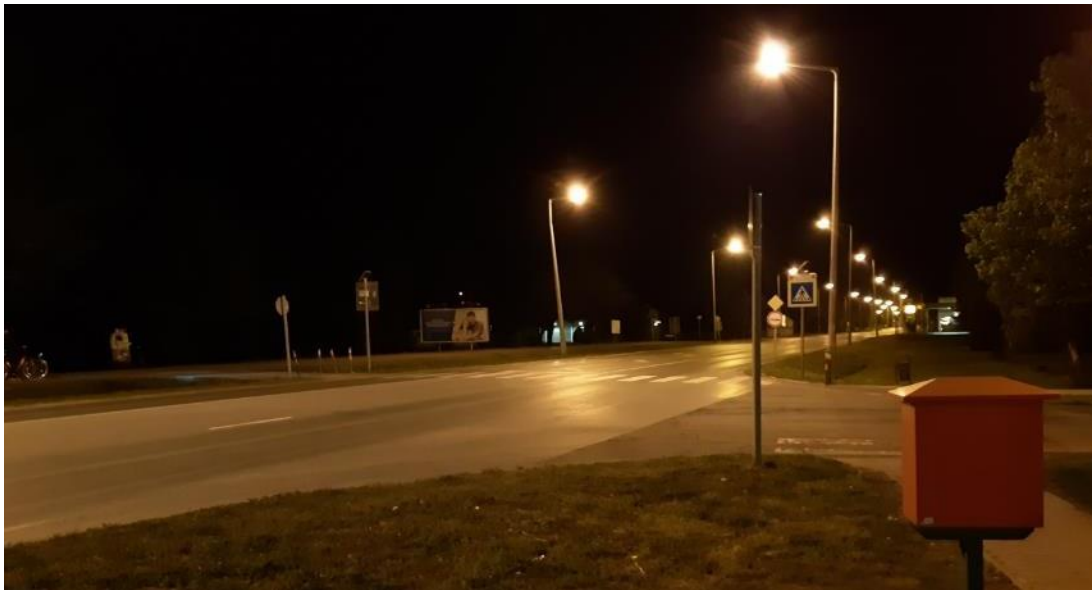
**Figure 5:** Photo of location at night

The common pedestrian and bicycle path can be found on the south side of the main road and typically used by cyclists (also in some cases by riders of electric bikes and mopeds). From the direction of the common pedestrian and bicycle path there is a “STOP” sign for the cyclists. From the east direction, the street lighting can only be found on the south side of the road, while after the pedestrian crossing it can be found on both sides of the road (the changing point is exactly at the pedestrian crossing, see Figure 5).

The common pedestrian and bicycle path is not luminous, while the parking lot of the shopping centre at the north side is luminous.

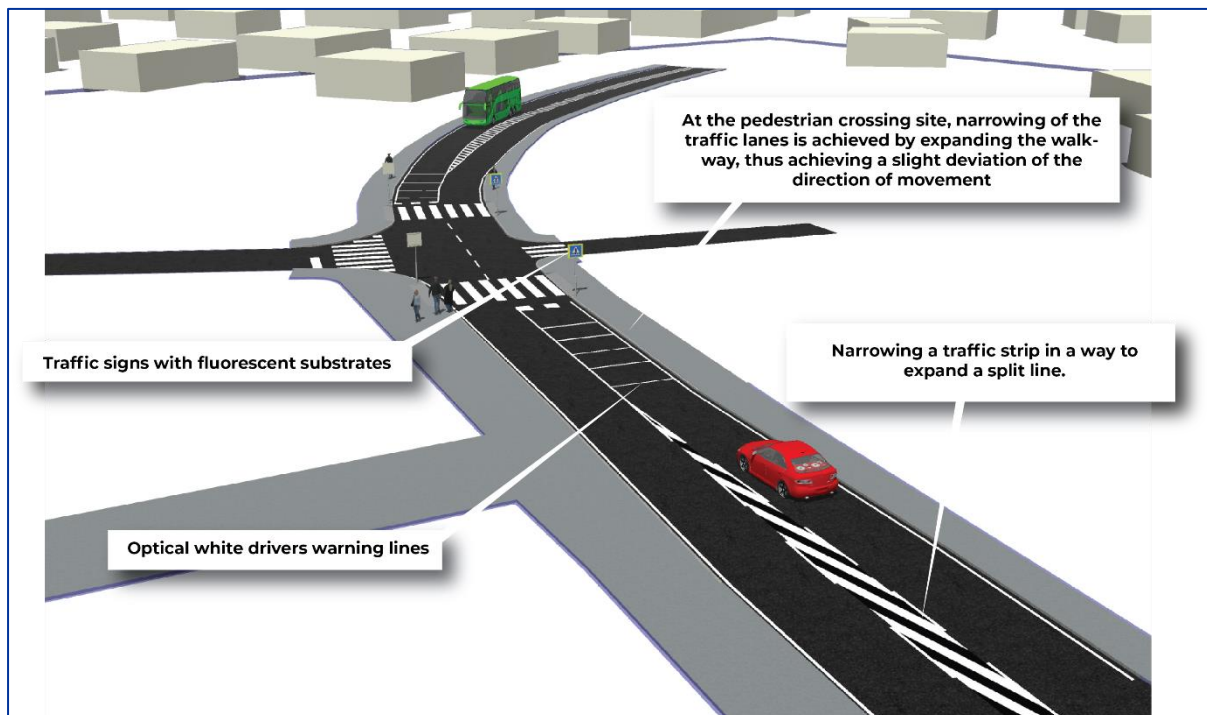
**Figure 7:** Potential infrastructure upgrades

In order to increase safety, it is recommended to set up optical white lines for visually warning drivers, zig-zag lines or audible warning lines when approaching the pedestrian crossing. Increasing safety is also suggested by upgrading existing vertical signaling to ensure its better detection. This can be achieved by increasing the retroreflectivity of traffic signs by fluorescent backgrounds or blinking lights.

**Figure** shows a view of potential infrastructure upgrades in order to raise the safety of vulnerable road users.

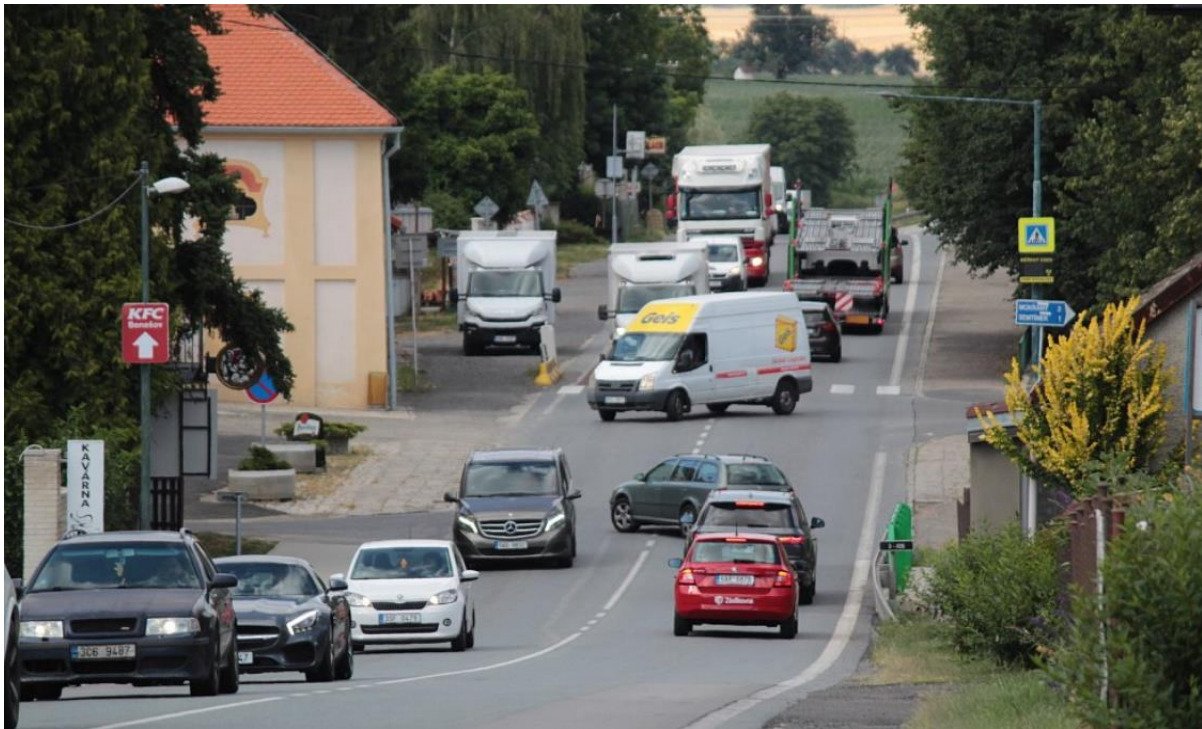
**Figure 9:** Daily traffic situation in Olbramovice

As a consequence, many municipalities located on the existing I/3 road suffer from high traffic volumes (almost 30.000 vehicles per day), large portion of heavy vehicles and significant air pollution. Since the road safety condition and provision of facilities for vulnerable road users along the I/3 through-sections is going to be the subject for Czech pilot study to be elaborated within RADAR project WP5, the following exemplary case illustrates one of such sections, probably the most controversial and escalated both publicly and politically – the town of Olbramovice.

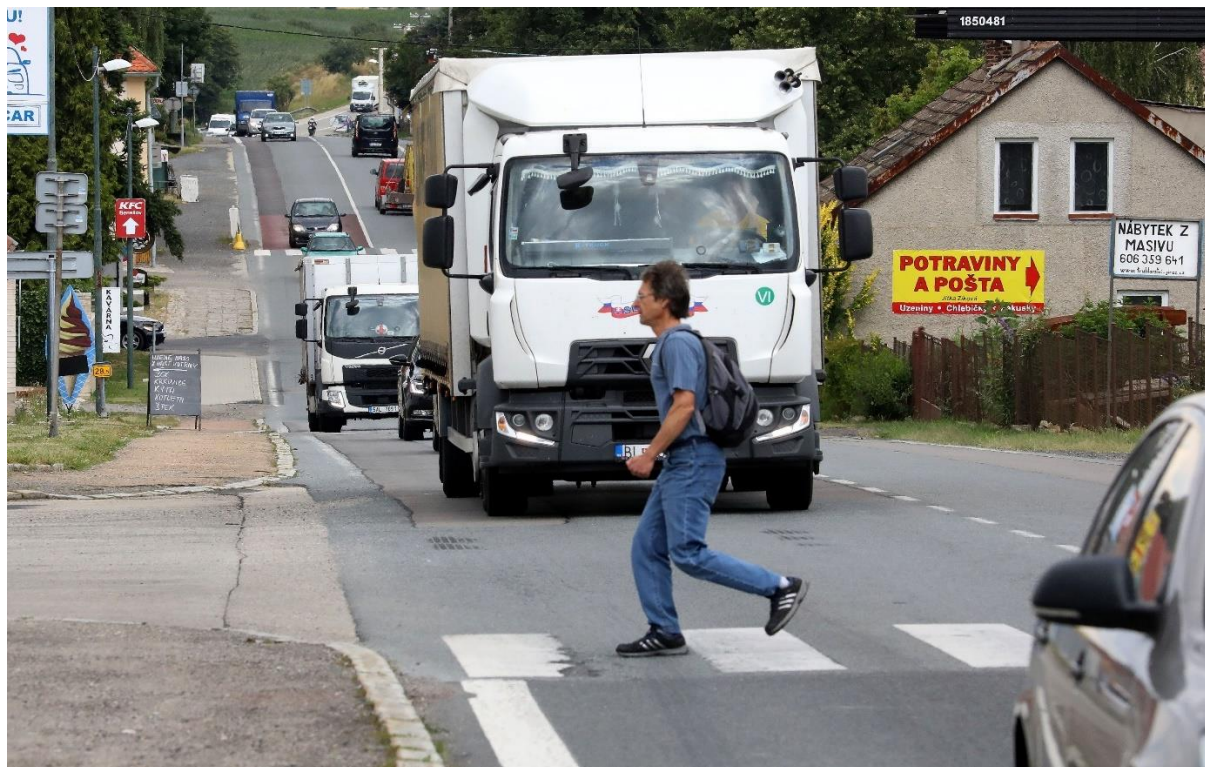
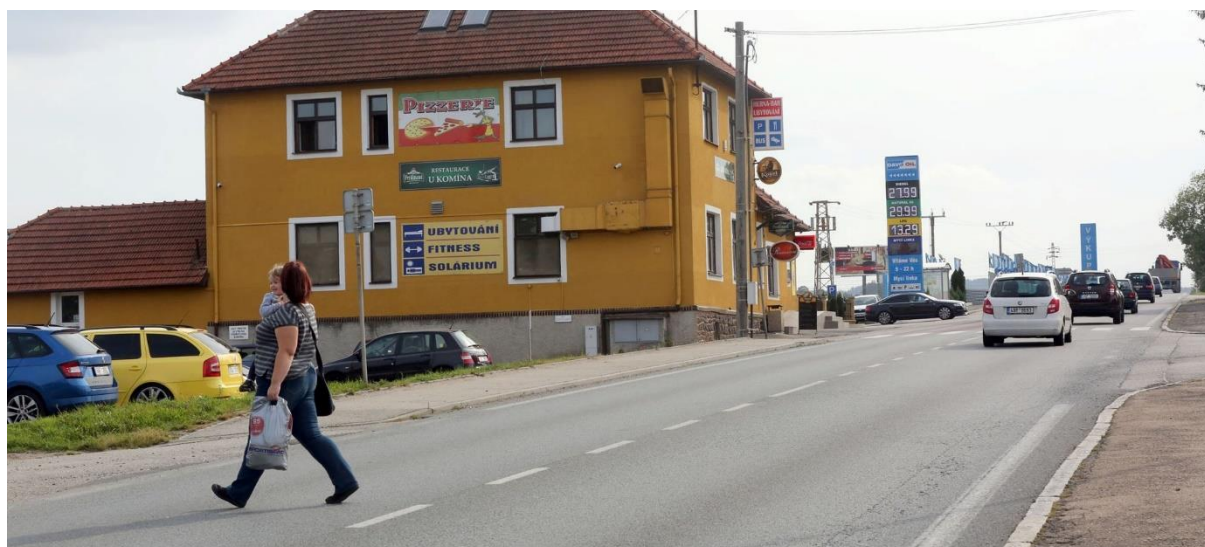
**Figure 11:** Pedestrians in Olbramovice

The pictures below illustrate the state-of-the-art condition of provisions for VRUs, which is insufficient and not convenient enough to make locals use it, resulting in risky situations in traffic.

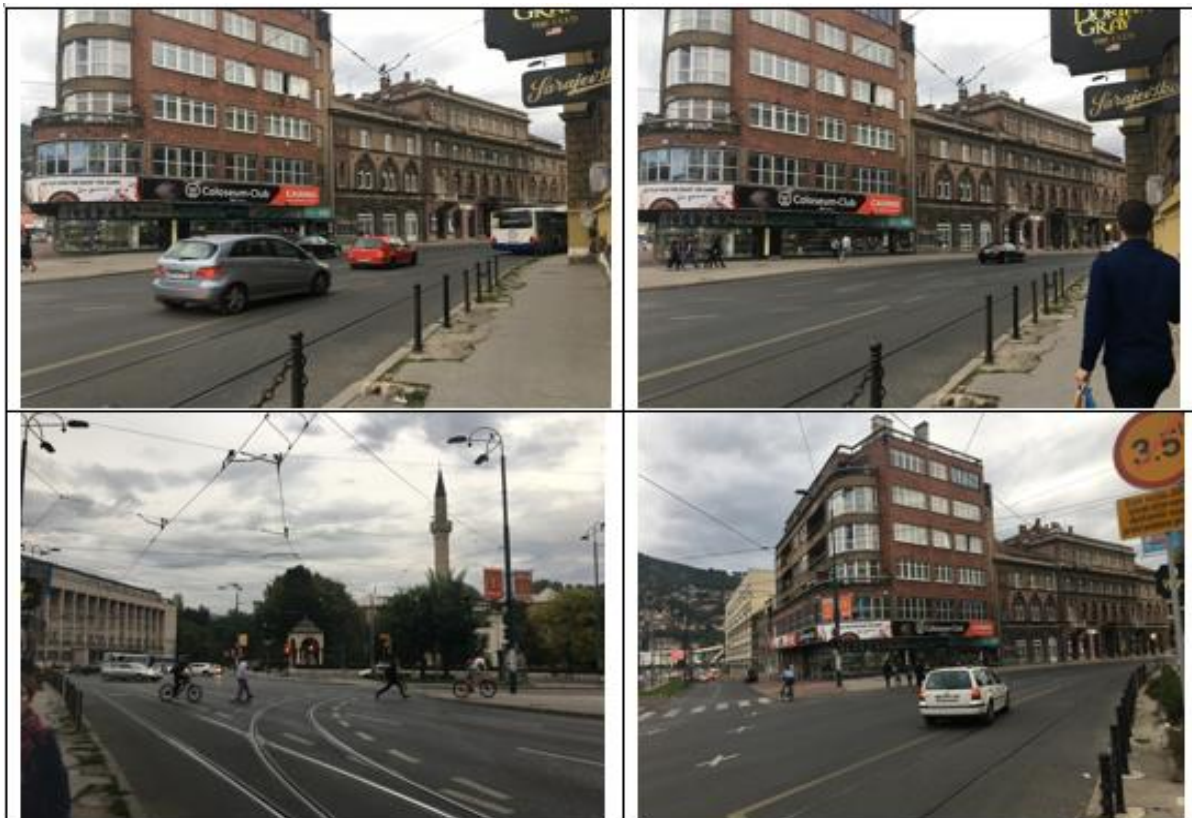
**Figure 13:** Photos of location, Skenderija

This street consists of three traffic lanes and one tram lane. Speed limit of this section is high 60 km/h where vehicles often are driven at 70-80 km/h, especially at night.

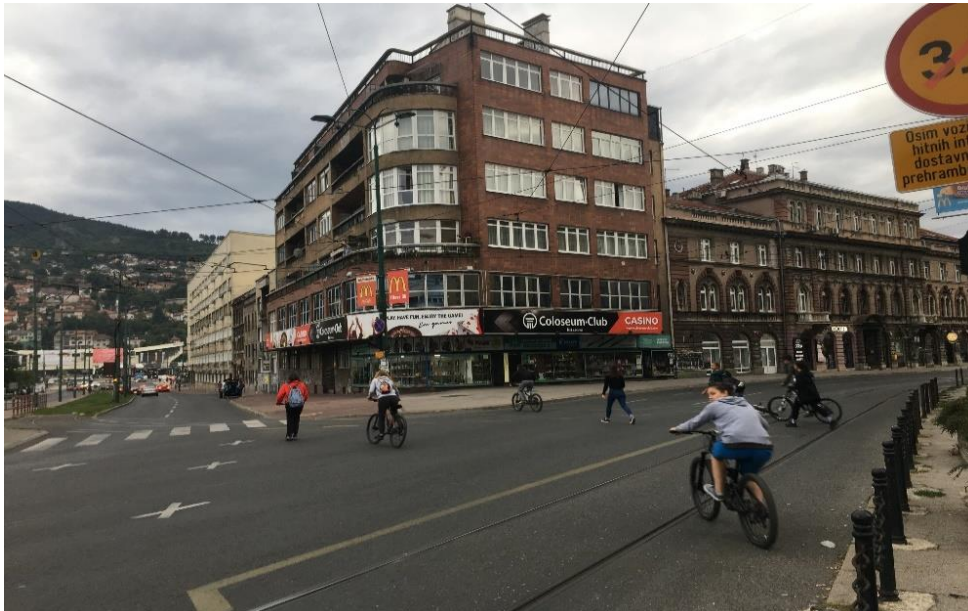
**Figure 14:** Pedestrians and cyclist crossing the road

The problem comes in situations where pedestrians or cyclists are "hateful" to make the round to cross the intersection and because of that they run across the road and endanger their own lives, as shown on the photo below.

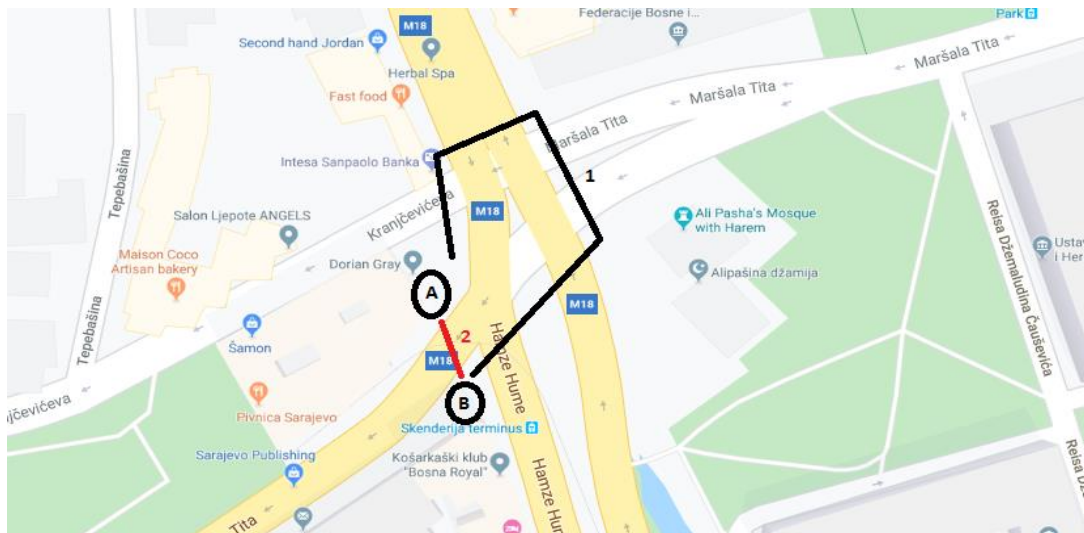
**Figure 15:** Proper and improper way of crossing road

In the picture below we can see the proper way of crossing the road (line 1) and improper (line 2) that use many of vulnerable road users. We can see that the line 2 is shorter and faster but it's more dangerous.

To increase safety, we propose fencing to prevent vulnerable road users from crossing the street and thus improving their safety at this intersection.

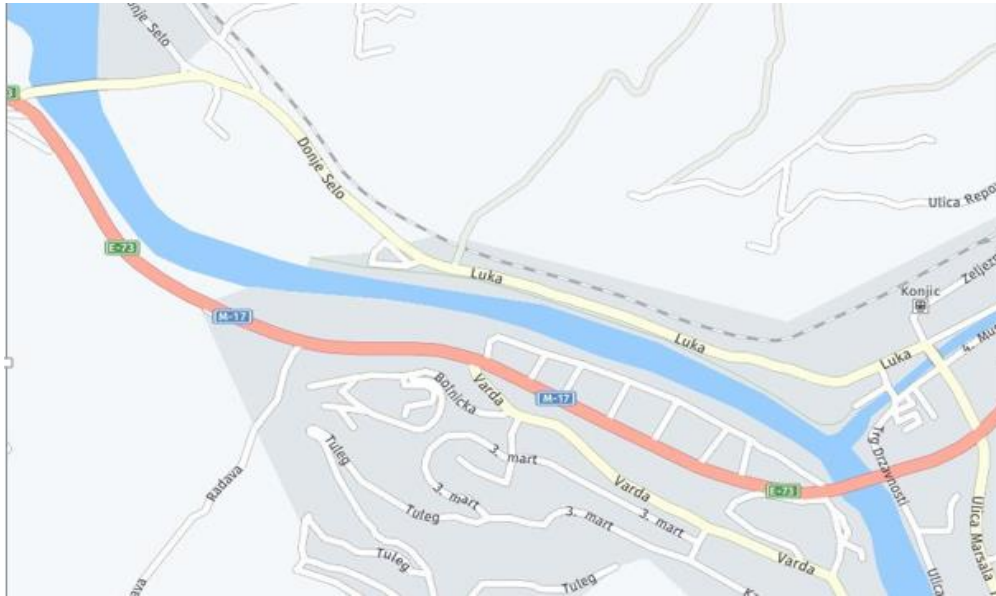
**Figure 16:** M17 – Konjic

The M17 main road passing through the populated town of Konjic is a very congested road with an AADT of 10.000 vehicles per day. Road section is in populated place with high intensity of movement of vehicles and pedestrians, cyclist, etc, and it is our duty to improve traffic safety on this road.

The road consists of one carriageway with two traffic lanes. M17 connects the northern and southern parts of Bosnia and Herzegovina and it's one of the busiest sections with high traffic volumes and large portion of heavy vehicles.

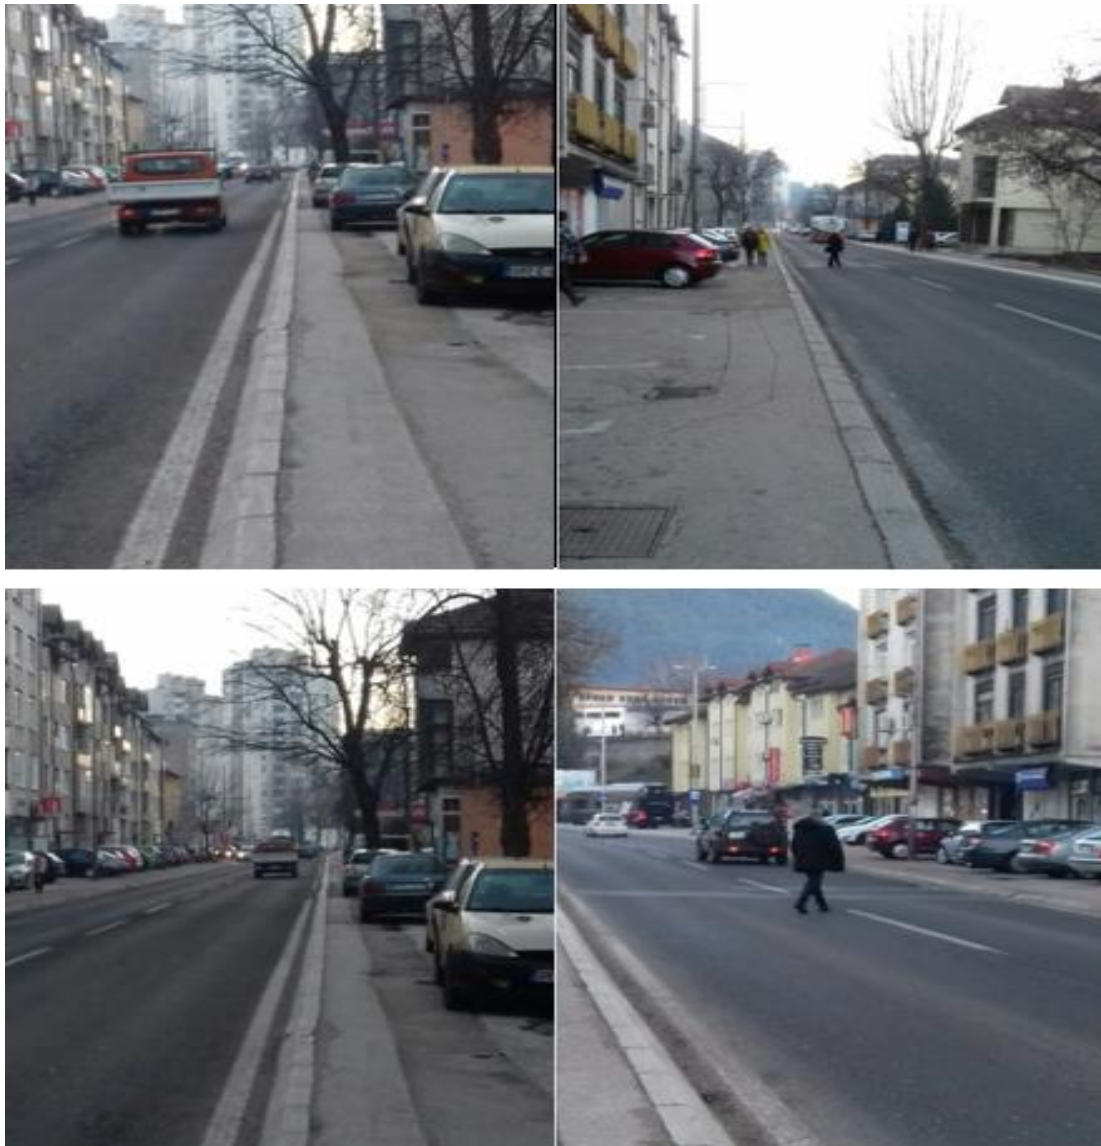
**Figure 17:** Photos of location, Konjic

In the period from 11. to 17. of September 2018. three road accidents took place on this 200-meter road, in which two people sustained injuries. From September 2017. to May 2018., eight traffic accidents were registered and six people were injured.

At the beginning of the school year, this problem became even more pronounced, because from only three solitaires in this settlement, almost 100 students go to the First Primary School. This means that they risk their lives every day by crossing this road.
